TSCA Report

S.J. Nudelman and Son
2707 N.W. Nela Street
Portland, OR 97210

June 13, 1994 11:15 AM

Inspection Authority and Purpose

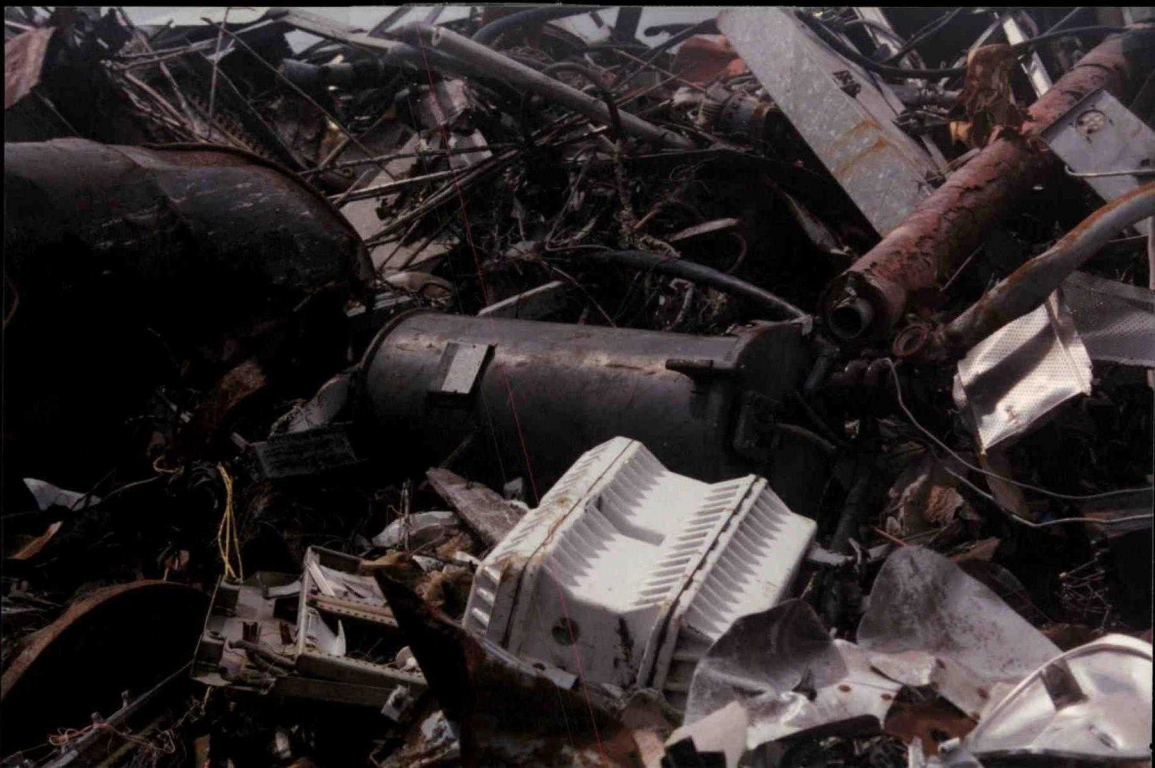
S.J. Nudelman,
Portland,OR,HEISTER
6/13/94 PHOTO #18

We next proceeded to the area located directly behind the fence adjacent to the fire area. This area was literally smothered in blackberry bushes and by the end of the tour both my and Bruce Long's Tyvek coveralls were in shreds. This area can best be seen in photo #7 which shows a huge pile of scrap behind the barbed wire topped fence. Atop this pile was the Westinghouse single phase S-Transformer (Serial #72U172) seen in photo #18. The name plate did not indicate the type of dielectric. In retrospect, I took considerable risk to reach this transformer, which was about 20 feet high atop a huge pile of scrap. After having done it once I would not have attempted it again. As best we could tell this was the only visible transformer on the entire pile. Photo #19 shows the pile from the reverse angle of photo #7

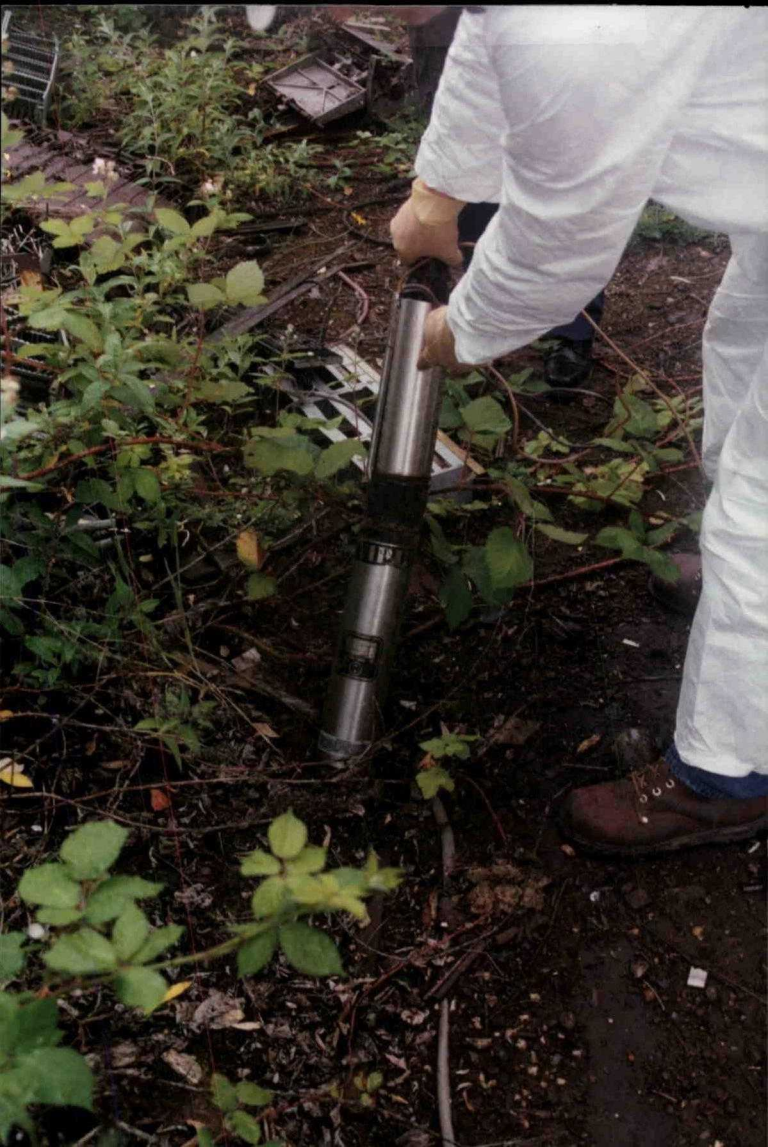
S.J. Nudelman,
Portland,OR,HEISTER
6/13/94 PHOTO #24

We pressed on and came across the nine large bushings seen in Photo #22. They appeared to be large transmission type bushings however we were unable to locate any name plates on them. Just to the right of these bushings we found a pile of submersible pumps used for domestic wells. The units were similar to those involved in the Valley Pump and Equipment case conducted in 1991 in Klamath Falls, OR. Photo #23 shows this pile of approximately twenty units and Photo #24 is a close up of one of the units. This unit was also the source of the wipe sample #94244565.
